Manhole Inspection Summary

Manhole # S21K1_002MH

Location Address: **3024 stranden rd**

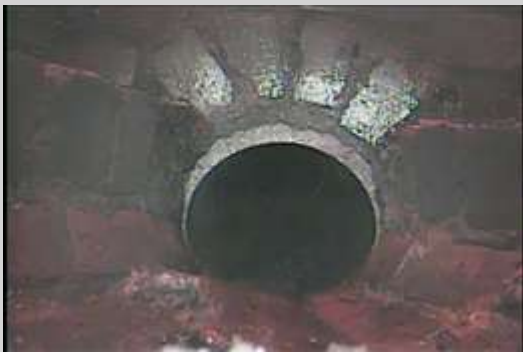
12 O'Clock Outflow

8 in. Circular Gravity Sewer
Pipe Out @ 12 O'Clock

Pipe Height: **8.4** (in.) Rod and Bar (Angled)
Pipe Material: **Clay** ☐ Pipe Lined
Invert Depth: **10.04** (ft.) Flow Characteristics: **Slow**
Deposits: ☒ None ☐ Mud ☐ Sludge ☐ Debris ☐ Grease
Silt Depth: **0** (in.) Deposits Extent:
Infiltration: **None** Pipe Seal Cond: **Sound**

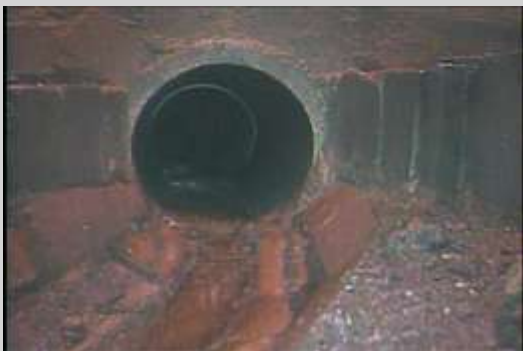
3 O'Clock Inflow

8 in. Circular Gravity Sewer
Pipe In @ 3 O'Clock

Pipe Height: **8.4** (in.) Rod and Bar (Angled)
Pipe Material: **Clay** ☐ Pipe Lined
Invert Depth: **9.75** (ft.) Flow Characteristics: **Slow**
Deposits: ☒ None ☐ Mud ☐ Sludge ☐ Debris ☐ Grease
Silt Depth: **0** (in.) Deposits Extent:
Infiltration: **None** Pipe Seal Cond: **Sound**
